GEOTECHNICAL AND STRUCTURAL ASSESSMENT REPORT

FISHER BORDER WALL
Mission, Texas

MEG Project No. 01-20-29170

Subject: Geotechnical and Structural Assessment Report
MEG Project No.: 01-20-29170
Fisher Border Wall
Mission, Texas

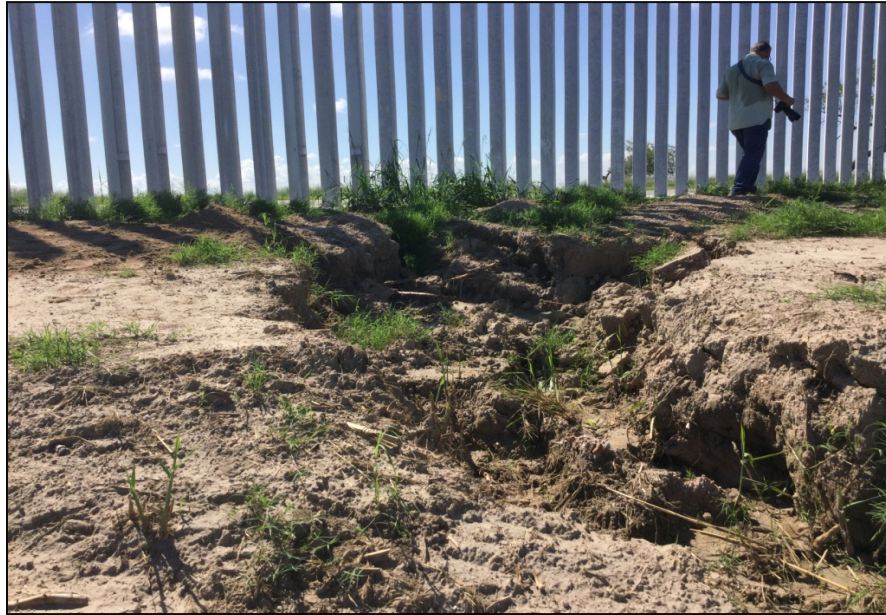
Photo 1 – Large Areas of Erosion

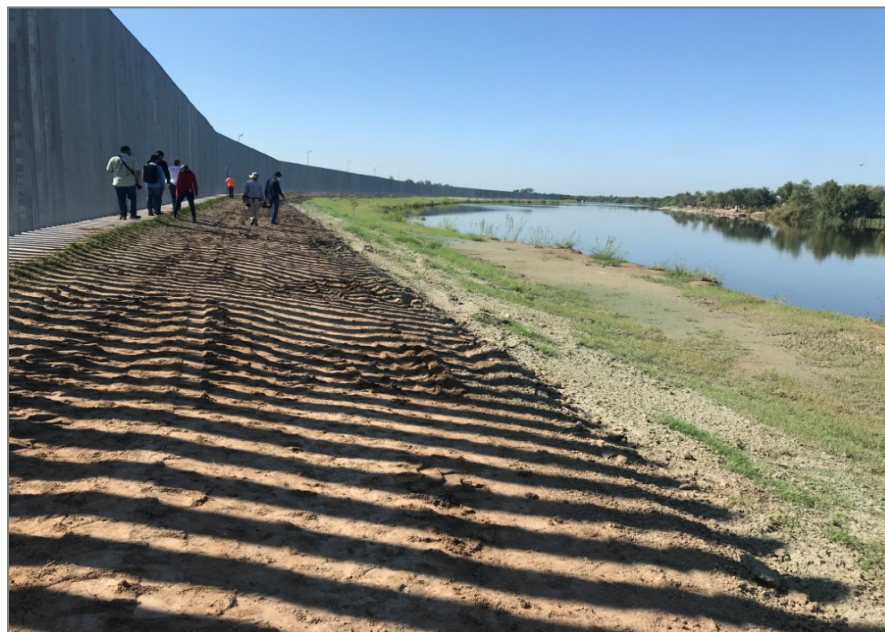
Photo 2 – Re-graded Embankment at start of inspection

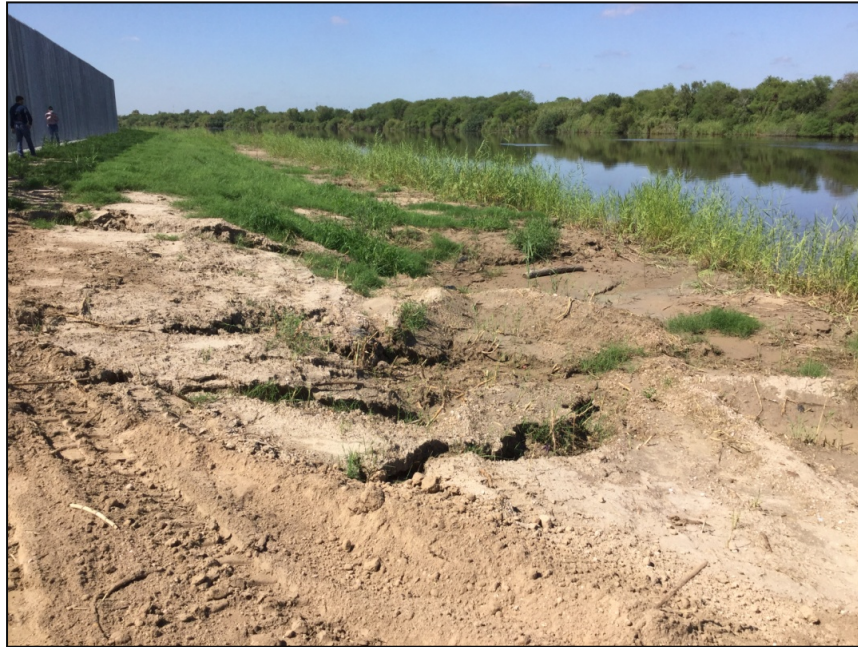
Photo 3 – End of Re-grading of Embankment; approximately one mile east from the start of the wall alignment

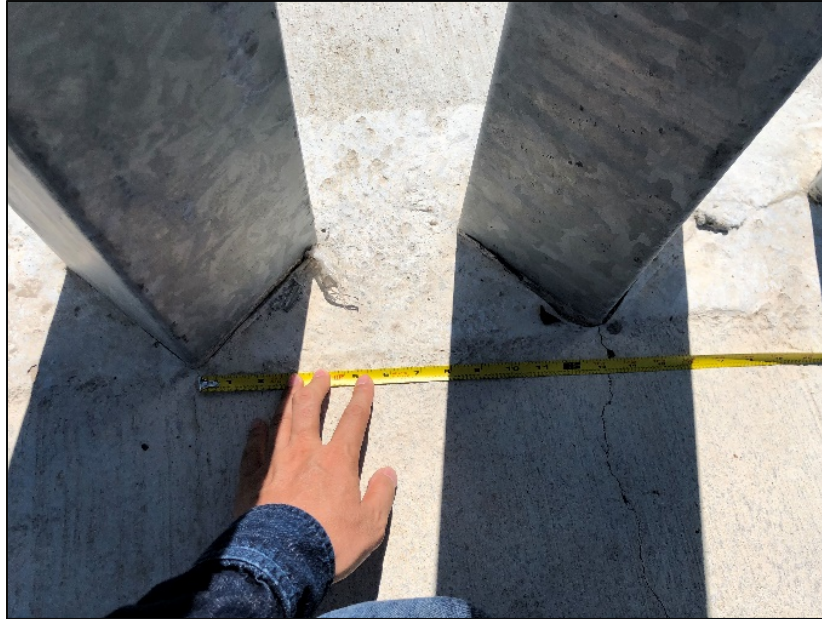
Photo 4 - Typical Bollard Separation

The wall bollards are made of corrugated steel 6 inch x 6 inch pipes imbedded into the concrete footing. Their spacing's are approximately 13 inches center to center. The bollards are rotated 45 degrees to each other to have about a 5 inch clearance, see *Photo 4*. The bollards stand 18 feet tall from top of foundation. Since no construction plans were submitted to our client, the depth of footing dimensions shown on *Figure 1* can only be estimated based on our visual observations and our experience with border wall construction.

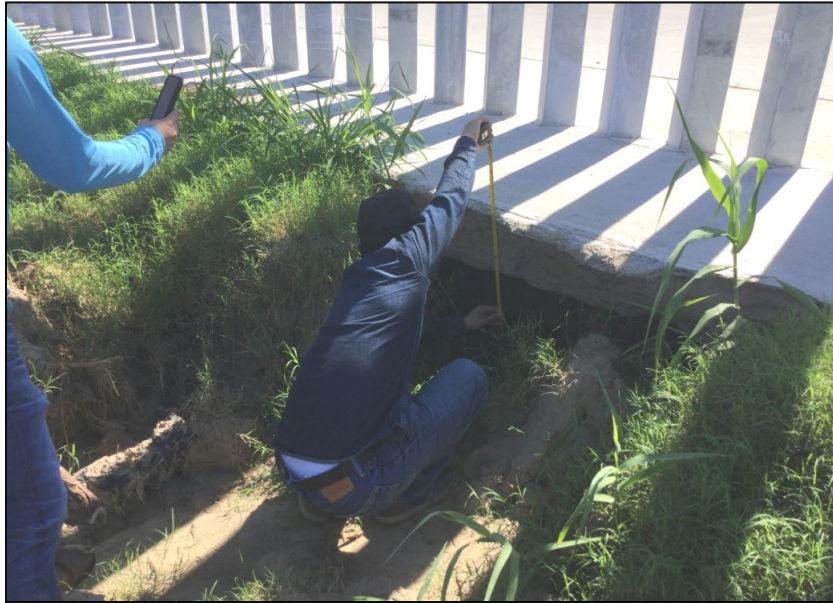
During our observations and assessment, various measurements were taken to determine the depths of erosion cavities and void spaces under the concrete foundation of the bollard wall.

Photo 5 – Measuring Soil Voids Under Foundation

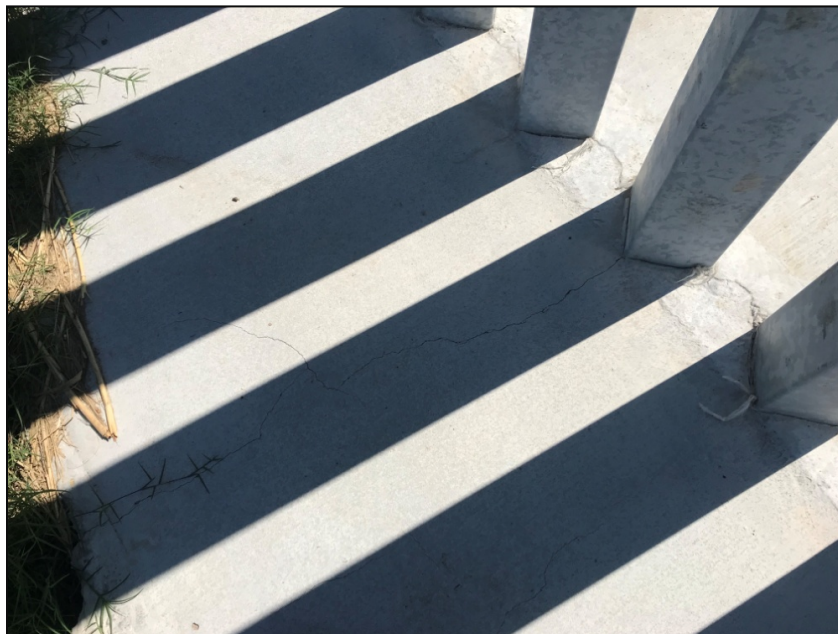
At the inspected locations, the bollard wall appears stable. Concrete paving is located on the landside of the bollard wall and does not show any signs of cracking, shrinkage, or deflection. The cracking of the wall foundation exhibited cracks less than 1/8 inch in width, see *Photo 6*.

Photo 6 – Concrete Shrinkage and Cracking Signs

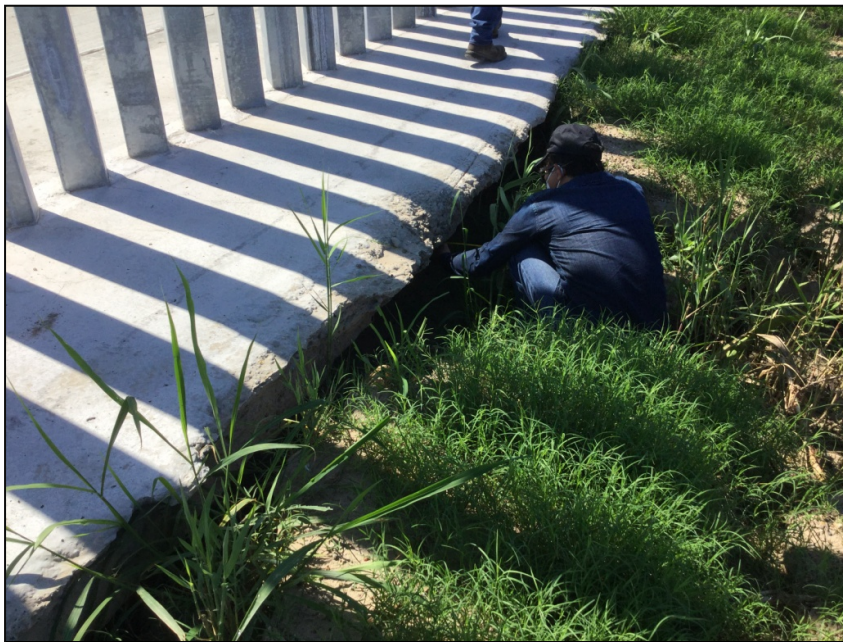
poured strips. The concrete slump at these locations appeared to be on the drier side of the moisture range when the concrete strip was poured, see *Photos 7 and 8*.

Photo 7 – Spalled Concrete Edges of Pour Strips

It was evident the riverside foundation was poured without formwork. The concrete exhibited rough and segregated edging along the entirety of the foundation, see *Photos 7 and 8*. Most of the areas of segregated edging had spalling issues as well as exposed

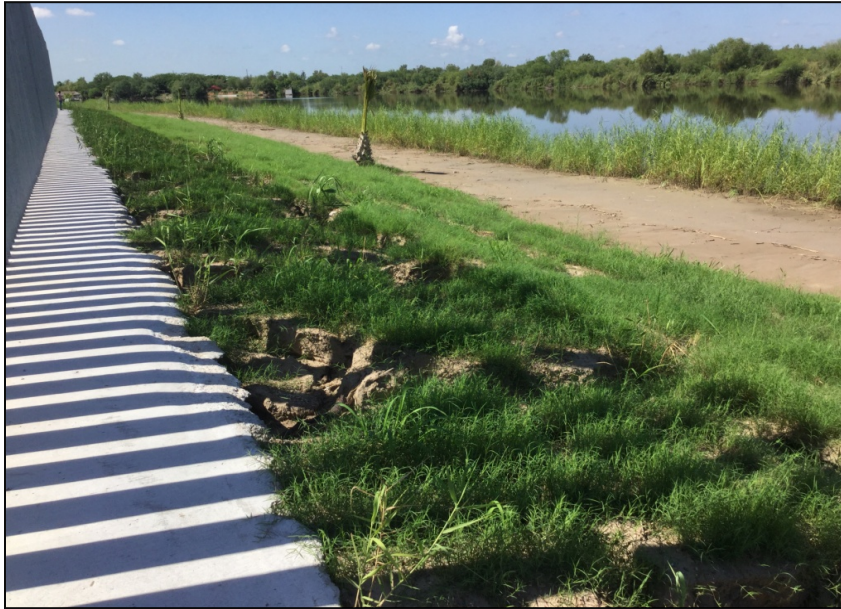
aggregate indicating concrete with dry conditions of efflorescence. The thickness of this concrete edging was varying in depths, see *Photo 8*.

Photo 8 - No Form Work Utilized

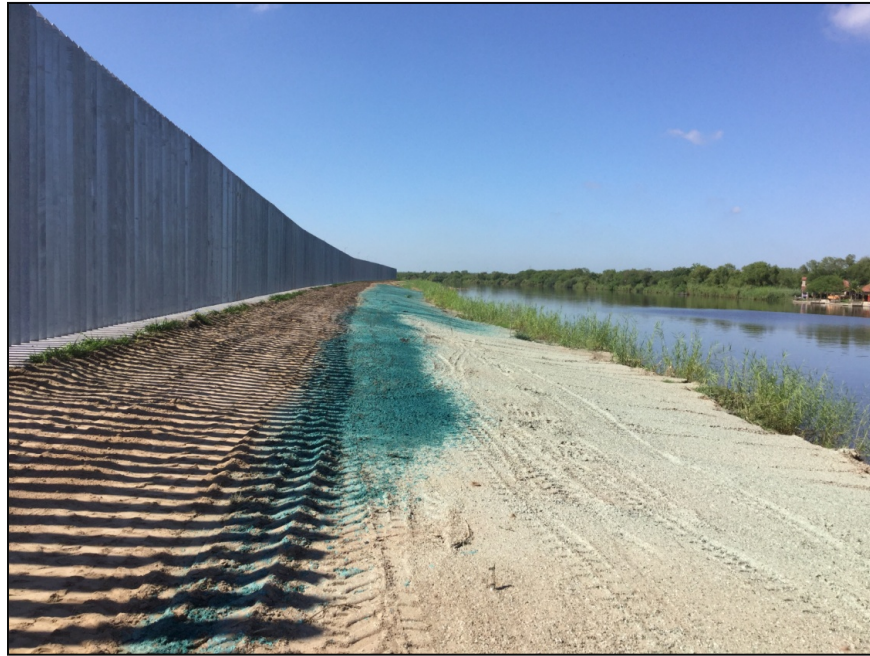
The embankment area on the riverside of the wall appeared to be a 5:1 slope and is what was stated to our team. At time of our site visit, about one mile of the embankment had previously been re-graded by bulldozers. Most of the areas of the re-graded embankment did not have any grass germination and the invasive Carrizo Cane was growing back on the river bank, see *Photo 9*. The embankment on the river side appeared to be in stable condition.

Photo 9 – Re-graded Embankment

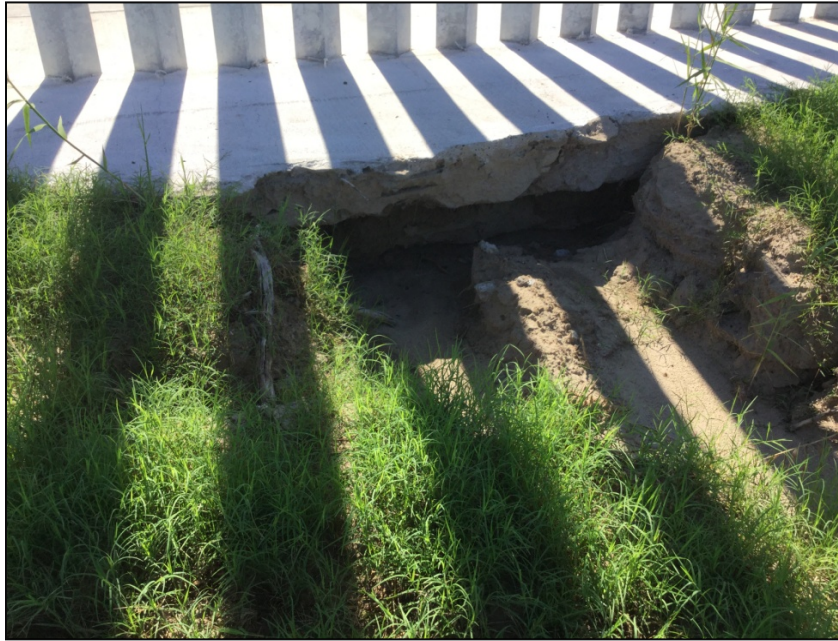
There are signs showing potential risks for the wall due to erosion. At various areas of the bollard wall, the soil under the wall foundation was eroded, which is visibly shown in *Photo 10*. Note that the time of the inspection occurred after *Hurricane Hanna*. Erosion of the embankment was 3 to 4 feet in depth in some areas; erosion width encountered was up to 2 to 3 feet. The actual working width of the pour strip foundation **B**, which is the sum of **B1** and **B2**, see *Figure 1*, was reduced considerably. In some areas the pour strip working width was reduced by 30%, affecting the overall stability of the wall by allowing

soil to be eroded and loss of the lateral capacity of the soil in the areas where erosion occurred.

Due to the erosion conditions, our technical concerns include:

- Center of the contact area of the foundation and the ground was moved toward the landside potentially causing an increase in the eccentricity,
- Bearing capacity of the pour strip foundation was reduced leading to a reduction in the factor of safety for bearing capacity,
- Reduction of the contact area between the foundation and the surrounding soil/ground can cause deformations, differential settlement of the foundation
- Shrinkage cracks are visible on top of the wall foundation; at the time of our site visit they are relatively small, however, these cracks may affect the performance of the foundation in the long term. This item should be reevaluated our time.
- The embankment should be sealed by a clay cap of impervious material to protect the existing embankment from erosion.
- Stone protection should be used to prevent erosion

Photo 10 - Erosions under Foundation

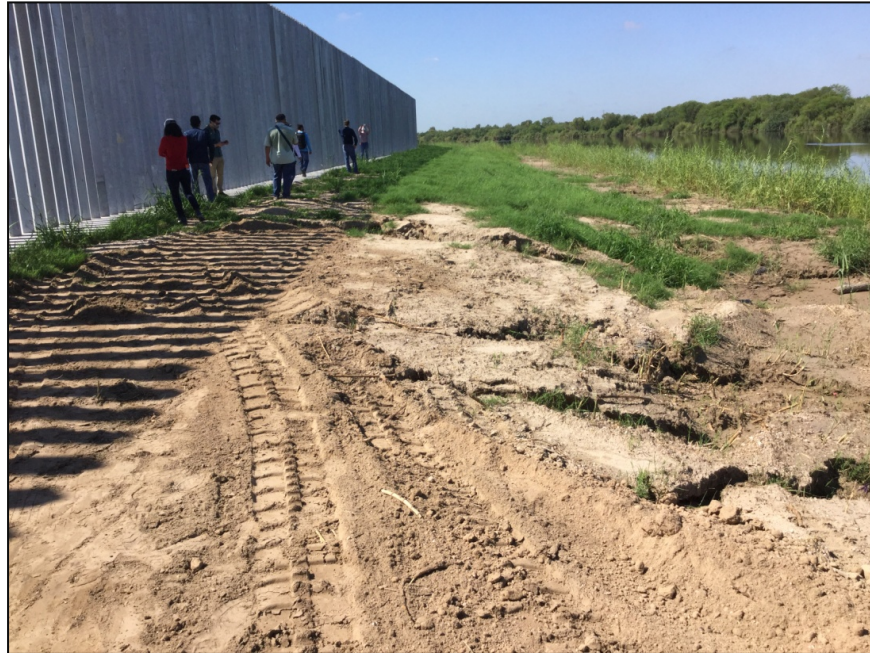
The native in-situ material closer to the base of the embankment was silty sand or sandy silt. The material is very susceptible to erosion due to its lack of cohesion. This material is sensitive in nature to saturated conditions and has considerable change in reduced shear strength when the loose sand is in saturated conditions.

No impervious clay cap or other forms of erosion control were encountered during the inspection. The soil type as installed has no erosion control and/or soil improvement. Native soil as installed will be challenging and prone to erosion effects in the event of saturated conditions, large rainfall events, or lack of maintenance.

Photo 11 - Silty-Sand Embankment Material

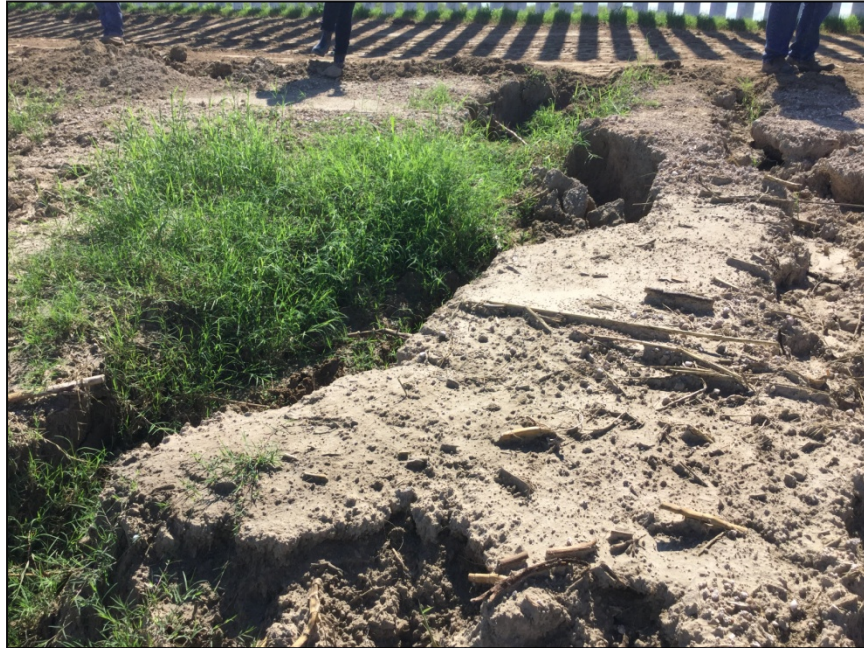
Long Erosion Crevices from Wall to River Bank

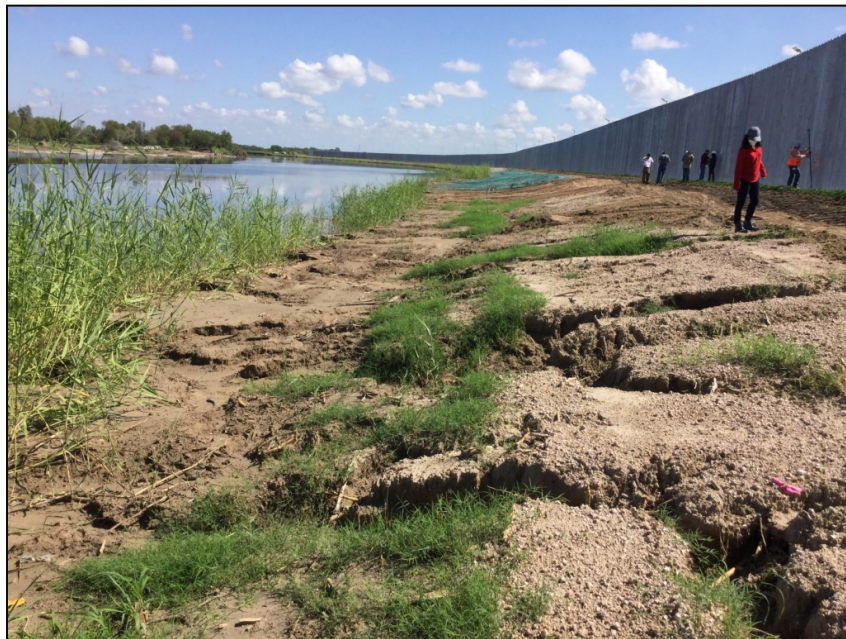
Elevation Profile of Embankment looking Westerly (Notice the Re-growth of the Carrizo Cane) (Minimal grass seeding germination) Large erosion voids
